# **Unitarian Universalist Fellowship of Briarcliff, Croton, and Ossining**

**Facility Study  
April 26, 2002**

**Molinelli Architects**

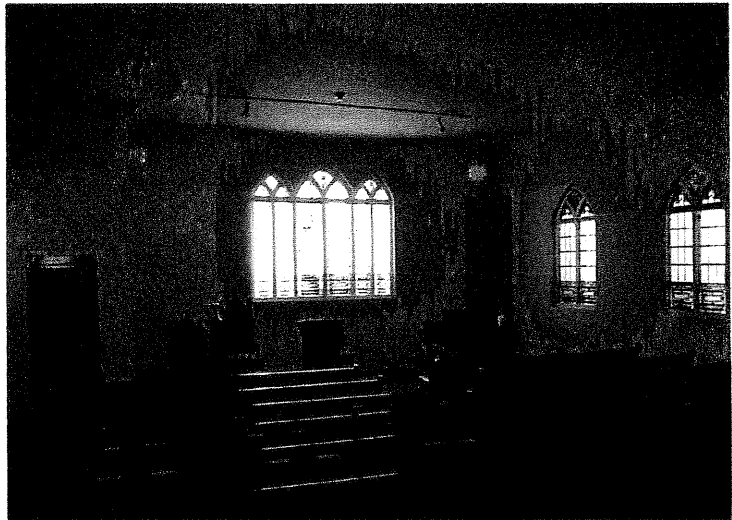
*The existing Chapel*

The Chapel building was probably built in 1920s. It is about 1,200 sf (30x40) with an entrance bell tower on the southeast corner. There are bats in the belfry. The terracotta has many foam patches in an effort to bat proof the structure. The quality of the terracotta wall structure is suspect at certain locations, but the church has held up for many years and no sign of major stress is indicated in the finishes. The plaster ceiling has some minor cracks at the curved areas around the perimeter which is common and not an indication of structural deficiencies. The exterior has some damaged stucco but is in generally good shape. The wood of the eaves and window frames needs to be scraped and painted. The stained glass could use more modern storms. The roof is also in good shape with a ridge vent indicating good ventilation.

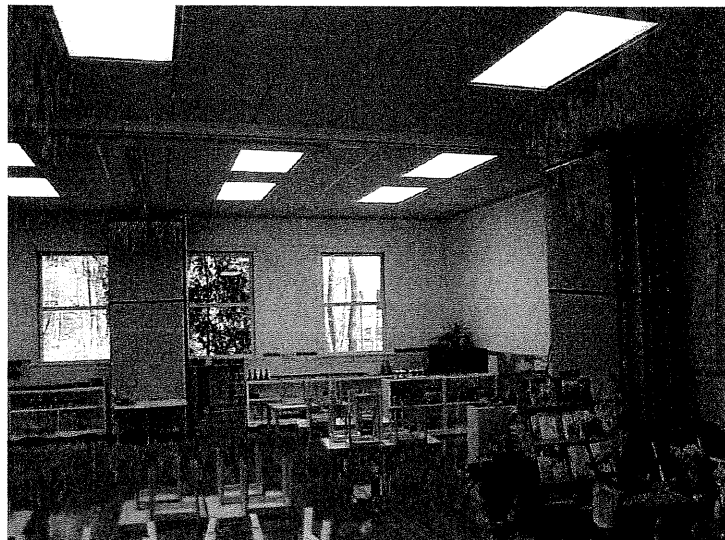
The addition to the church probably occurred in the '20s. It is about 2,204 sf (58x38). It has a full basement and a main floor with a kitchen addition that followed sometime afterwards. The basement level does not have a ceiling that meets the code requirement of 8'-0" for an occupied space. There is some ground water damage on the lower level.

*The existing social space*

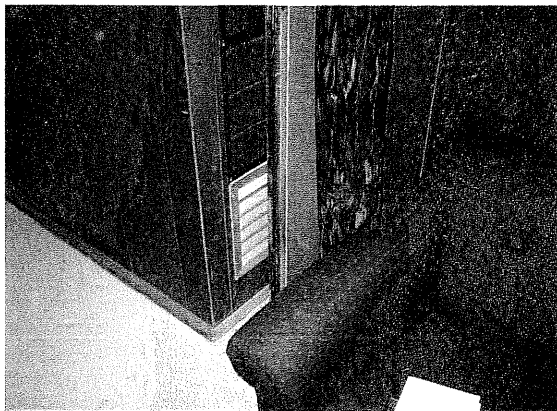
An exposed wood column, thin wood paneling and an open grille in a fire wall demonstrate the lack of fire protection

The chapel portion is ordinary construction (masonry walls, wood framed floors and roof) and the social space is conventional wood frame. The buildings are co-joined in such a manner that the lesser means of construction should govern the code review. The ceilings in the basement are often open joists or finished with homosote or plywood. There are unprotected columns in the basement. For this reason, we are classifying the building as unprotected wood frame construction used for an assembly occupation.

Certain deficiencies in construction classification need to be corrected. The kitchen should be separated from the social space by a two hour enclosure. The central entrance stair should be in an enclosed shaft. The unprotected columns and framing should be protected. The wall paneling needs to be replaced. The furnace room has attempted a rate door, but uses through wall grilles which violate any fire protection. Adding sprinklers to the building would increase the safety and compensate for other code irregularities but is not a requirement.

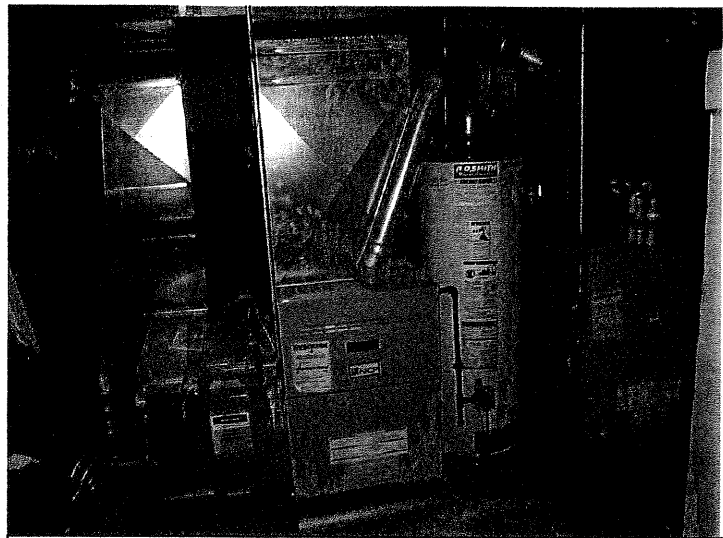
The building heat is provided by two NCP forced hot air furnaces located in a mechanical room in the lower level. One unit has an output of 150 MBH and the other 125 MBH. Each has a Honeywell electrostatic filter. Combustion gases go into the building chimney. Uninsulated galvanized steel ducts distribute the hot air throughout the building which goes into the rooms via floor or wall grilles. This equipment is in excellent condition and appears to have been well maintained and service. It appears to be adequate to the existing building configuration, but would not have enough capacity for any substantial expansion.

*The existing heating system was recently added.*
